URBAN KARST DRAINAGE PROBLEMS IN THE ENSOR SINK – TIRES-TO-SPARE SYSTEM,
COOKEVILLE, TN, USA

Abstract

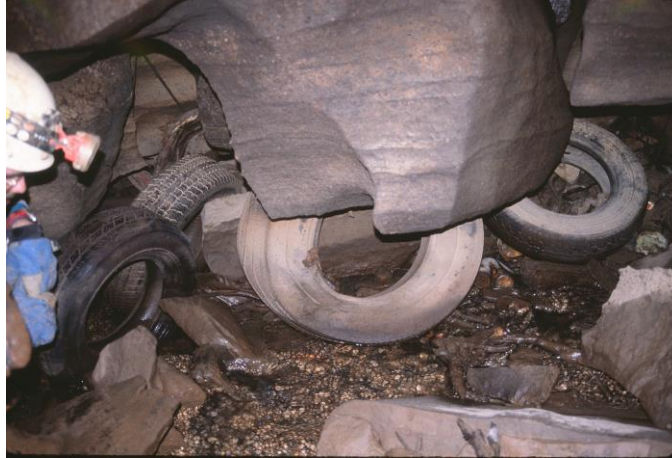
Figure 1: Four of over 30 tires in Tires-to-Spare Cave, accumulating at the base of the breakdown collapse.

On 25 April 1994, ceiling failure in a cantilever dome produced a collapse sink 31 m long, 13 m wide and approximately 10 m deep. The collapse broke through at least 2.5 m of bedrock to give entrance to a hitherto unknown active stream cave developed in the Warsaw Fm. (Mississippian) beneath the city of Cookeville, TN. Albeit a virgin cave, exploration and mapping of the 629 m long cave revealed it to contain urban debris in prodigious quantity and variety: Cans, cigarette butts, a plastic milk crate, automobile parts, toys, a baseball bat, one full beer, a pot, shoes, a lawnmower (?) wheel, commercial truck cargo seals, a shopping cart basket, 5-gallon buckets, lumber, motorcycle tires and over 30 automobile tires (one still on its rim!). The plethora of tires (Fig. 1) inspired the name Tires-to-Spare Cave (TTS).

Prior to the entrance collapse, the cave stream transported some large debris items (tires, buckets) through the cantilever dome room and on downstream. After the collapse, access to the upstream 381 m of passage was very nearly blocked. The breakdown pile now acts as a strainer removing all large and much small debris from cave floodwaters.

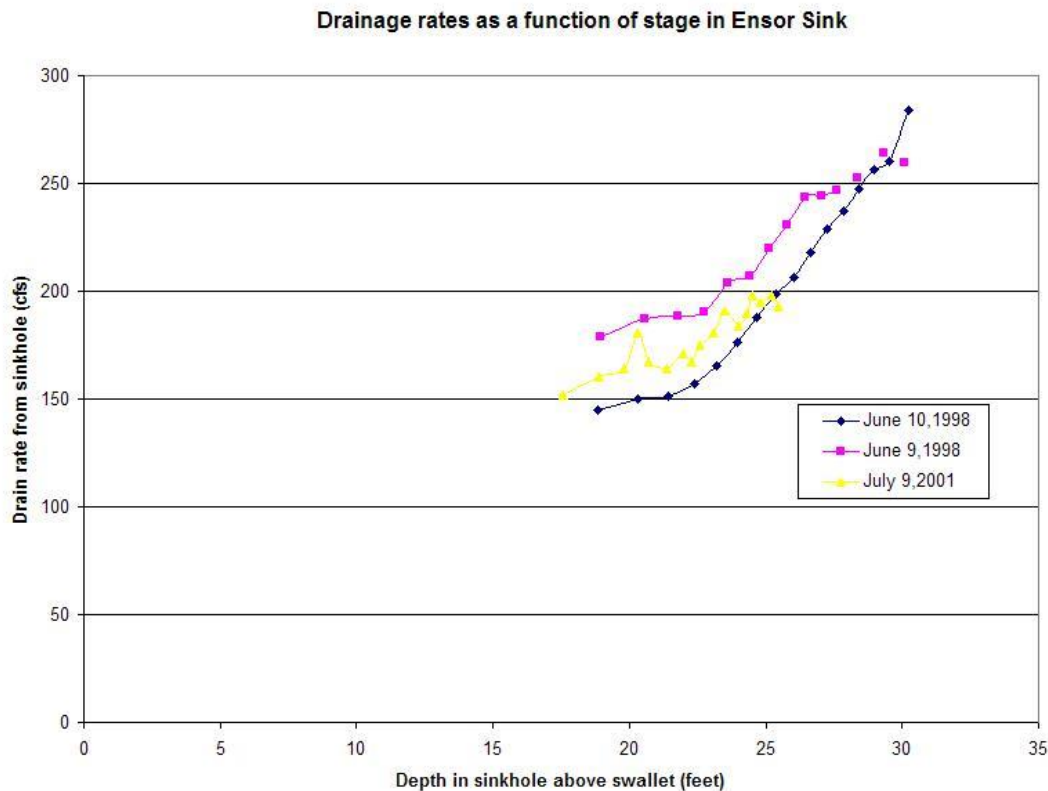
Figure 2: Drainage rates at Ensor Sink as a function of stage

Stage measurements in the sinkholes and discharge rates from BMB canal were used with sinkhole stage-volume relationships to compute average sinkhole drainage rates in ES over five-minute intervals for various water depths (Fig. 2). Knowing approximate drainage rates and watershed characteristics, flood levels for storms not witnessed during the course of the study (such as the 100-year storm) were predicted.

The BMB canal design allows brimfull discharge of approximately $28 \text{ m}^3/\text{s}$ (1000 cfs) near its terminus at ES. Hydrologic models incorporating our data indicate a peak discharge between $70 - 115 \text{ m}^3/\text{s}$ (about 2500 – 4000 cfs) during the 100-yr storm event, during which ES may hold up to about $125,000 \text{ m}^3$ (100 acre/feet) of water in temporary storage. In contrast, drainage rates from ES, as a function of stage, were calculated to be an order of magnitude less than the input: approximately $4.2 - 4.5 \text{ m}^3/\text{s}$ when flooded to a depth of 6.1 m (20 ft), and approximately $7.4 - 7.9 \text{ m}^3/\text{s}$ (260-280 cfs) when flooded to a depth of 9.1 m (30 ft).

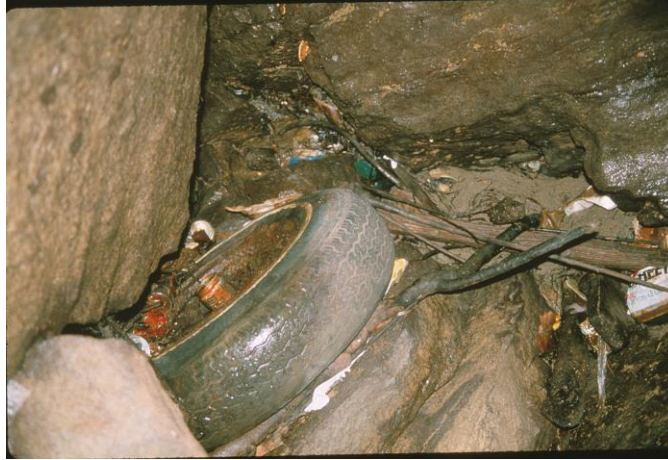
Figure 3: Tire on rim, cans, sticks, sediment, and other debris filling the interstices of breakdown “filter” in TTS Cave.

The fourth and best known constriction in the subterranean drainage is formed by the breakdown plug at the collapse entrance to TTS. Rapid, total flooding of a portion of the cave upstream from this breakdown pile is known to occur.

This, however, might be expected to change as the interstices of the breakdown "filter" become increasingly plugged by debris. (Fig. 3). During the course of this study an increase in ponding on the upstream side of the breakdown was observed, hinting at growing blockage in the lower levels of the breakdown pile. Additionally, an apparent increase in the degree of in-filling by trash of the interstices higher up in the breakdown "filter" was noted. If steps are not taken to control the influx of urban debris at ES, Cookeville may lose the services of an important natural storm sewer.
